Cable Failures off Oahu, Hawaii Caused by Hurricane Iwa

Charles D. Hollister

August 1984

Technical Report

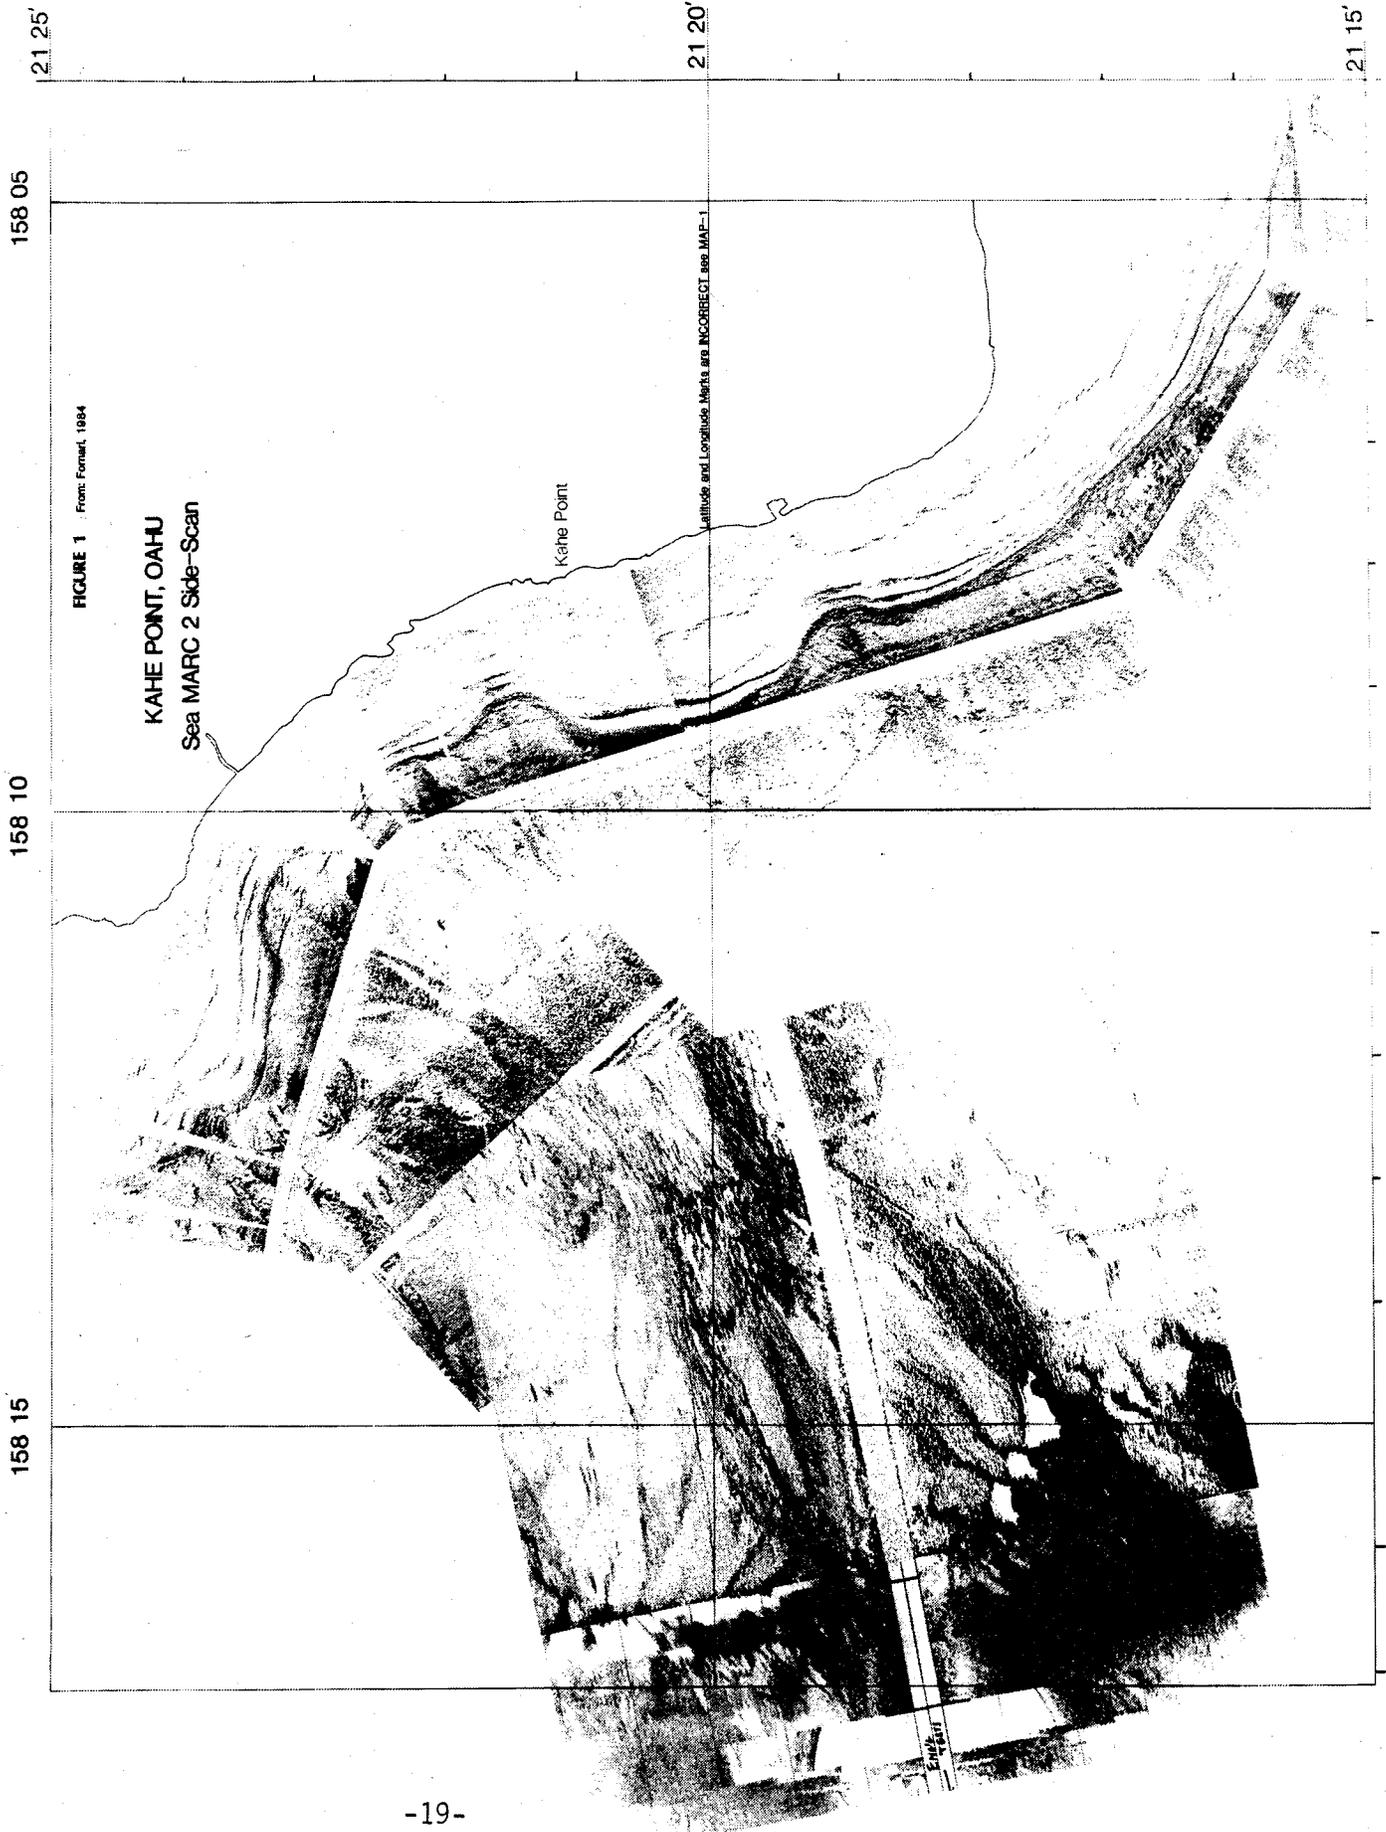
Fig. 1

Figure 1 shows the complete side-scan mosaic, as supplied by the Hawaii Institute of Geophysics (HIG). MAP-1 is an interpretative overlay of Figure 1 which portrays a variety of data including: acoustic reflectivity facies; DSV TURTLE dive locations (Fornari, 1983); current meter data (Noda, 1983); cable-break information; and major morphological features of the seafloor in this area.

Near the southwestern edge of the side-scan mosaic in Figure 1, there are several finger-like zones of seafloor which are characterized by narrow, alternating swaths of high and low reflectivity which create prominent acoustic shadows.

When one overlays MAP-1 on Figure 1, it is clear that the cable breaks are located in areas of high-reflectivity, especially the Oahu Tie and California-3 cable breaks which occur in high-reflectivity zones. Highly-reflective echo returns are typical of localized rubble/debris flows which were probably generated in the 400 fathom to 500 fathom area; this material was probably responsible for abrading and breaking the cables.

The most prominent feature in the deeper water area along the western edge of Figure 1 is the zone of landslide lobes. These finger-like acoustic features have positive relief over the surrounding seafloor as evidenced by the prominent acoustic shadows which are cast to the south of the tips of these features (MAP-1). In addition, it should be noted that these features are located at the break in slope between approximately 800 fathoms and 1200 fathoms where Normark et al (1982) suggests that this deep-water sea off Kahe Point may have been subjected to landslides in the geologic past, based on the presence of inferred chaotic terrain recorded on geophysical records.

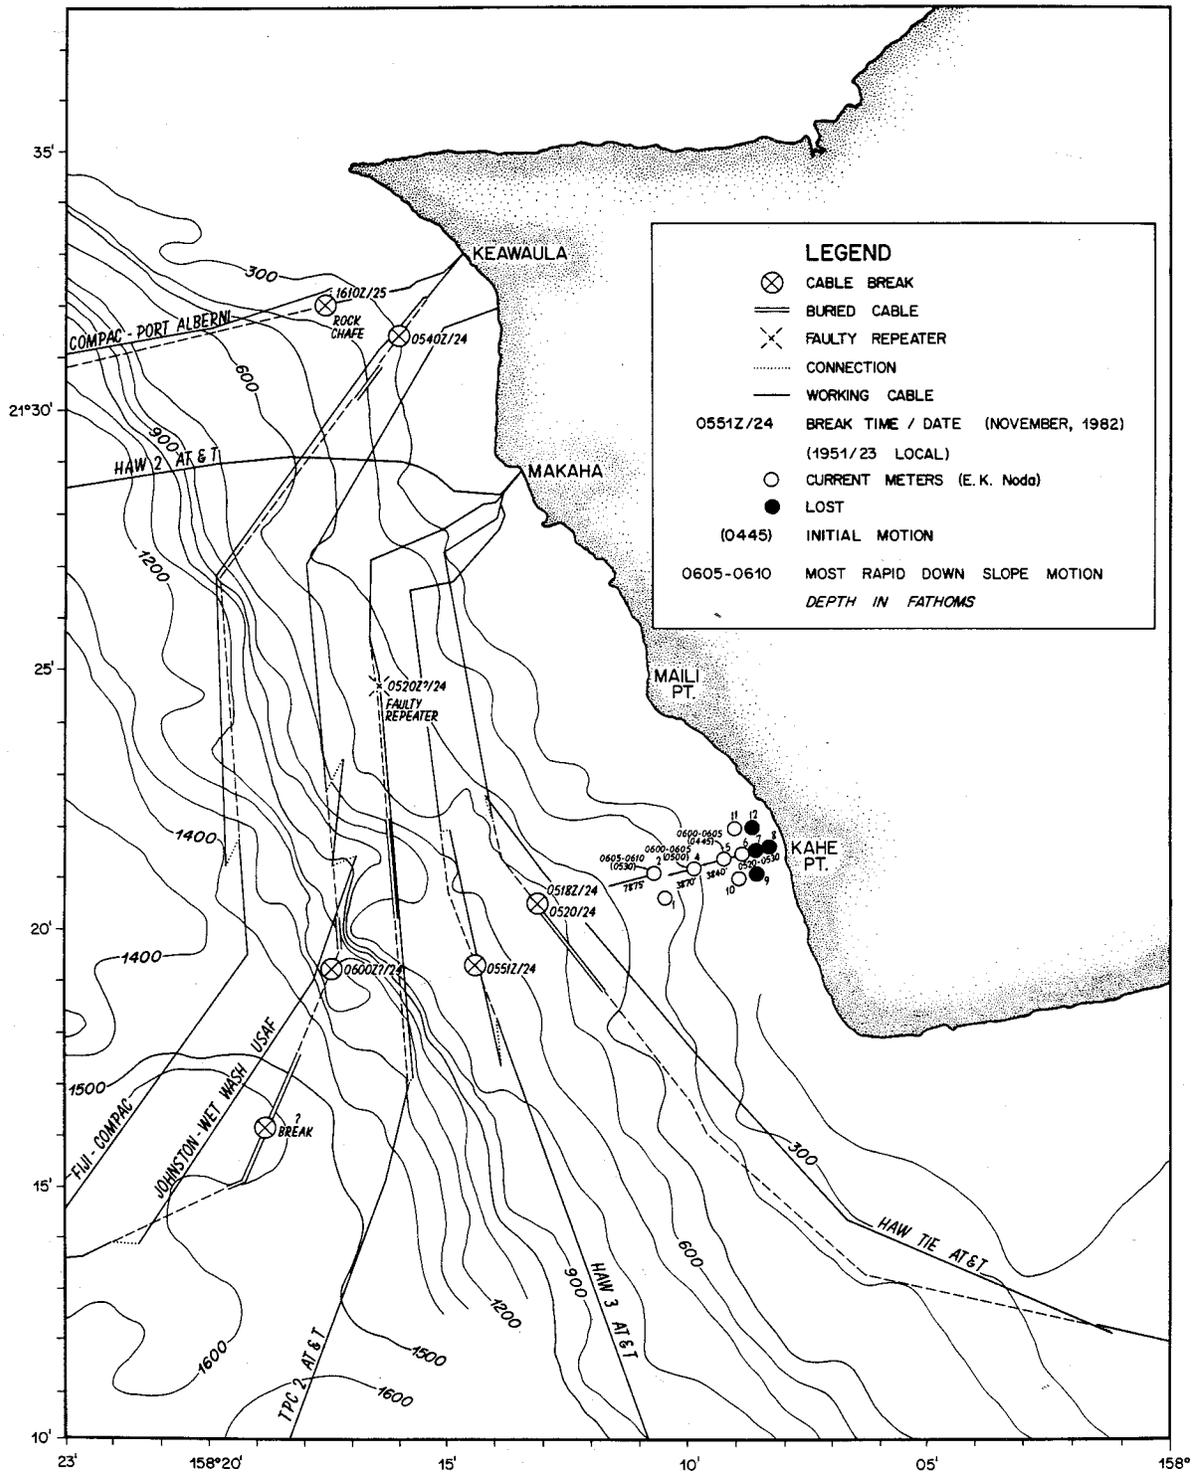
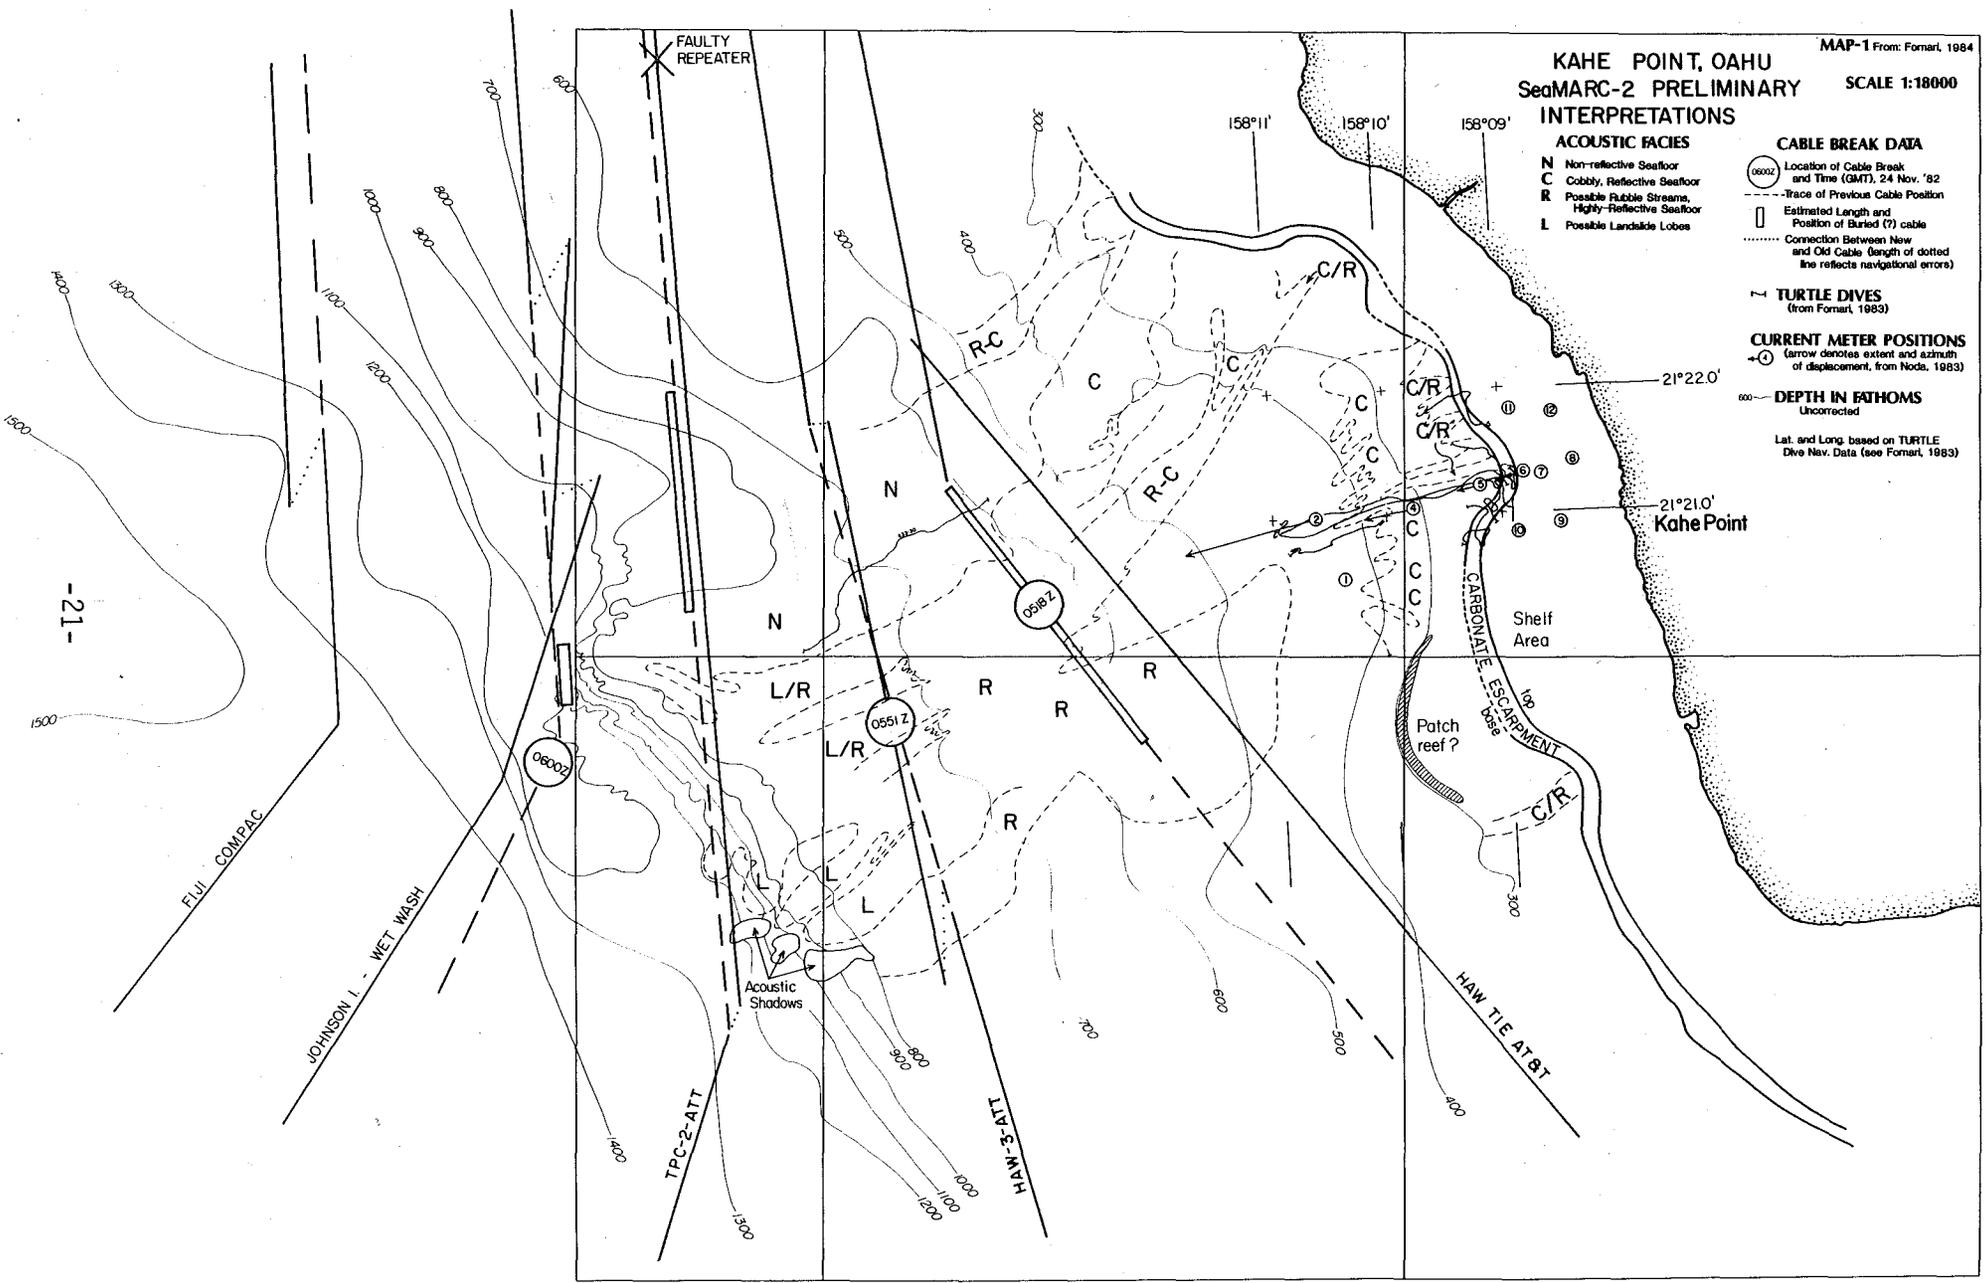
Fig. 1A - Index Map Showing Cable Failures and Current Meters Referred to in Text

MAP-1 contains all cable break data available for the outages which occurred during the Iwa off southwestern Oahu. A sequential, time progression for the breaks in these cables is apparent as one moves offshore. However, the Guam-2 A.T. & T. cable, which is the third cable out from shore (see MAP-1), was not broken.

As discussed in this report, the movement of the current meter arrays was sporadic and occurred over a large time interval between 0500Z and 0610Z, with the major displacement taking place between 0600Z and 0610Z. This time interval is much later than the times when the Oahu Tie and California-3 cables (ones closest to shore and the current meter positions, see MAP-1) parted. In addition, the break times for these two cables is very well constrained based

on the drum recorder records and is well within a few minutes of the times shown on MAP-1. Consequently, it is difficult to conceive of these two events being related by a single event.

The patterns of high-reflectivity seafloor as mapped on MAP-1 appear to coalesce and bifurcate principally in an up-and-down slope direction and the deeper water high-reflectivity zones seem generally continuous with narrower zones of highly-reflective seafloor in shallower depths. While the contrast between the right and left-hand sides of each side-scan record is influenced by whether the instrument is insonifying an upslope or downslope area of seafloor, it is clear that the most highly-reflective zones occur in water deeper than approximately 500 fathoms (uncorrected).

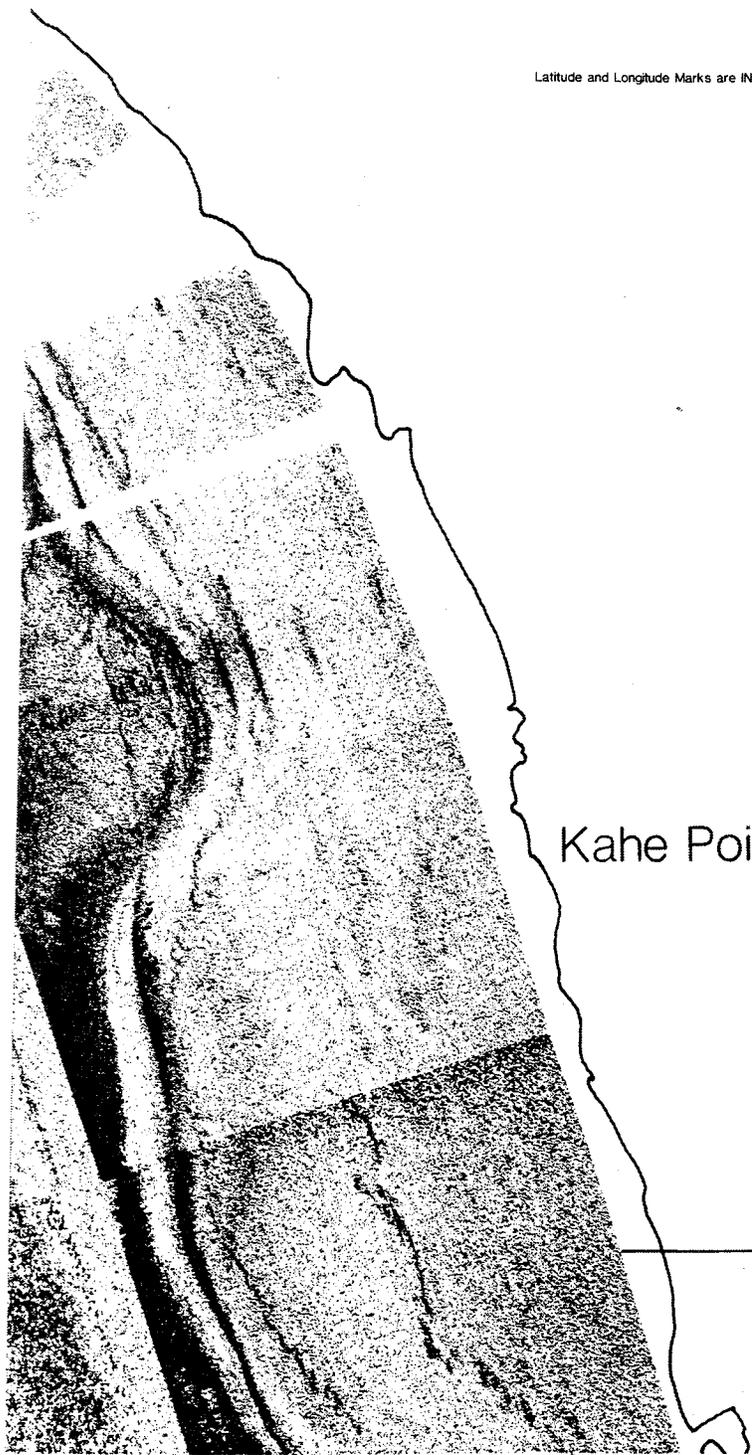
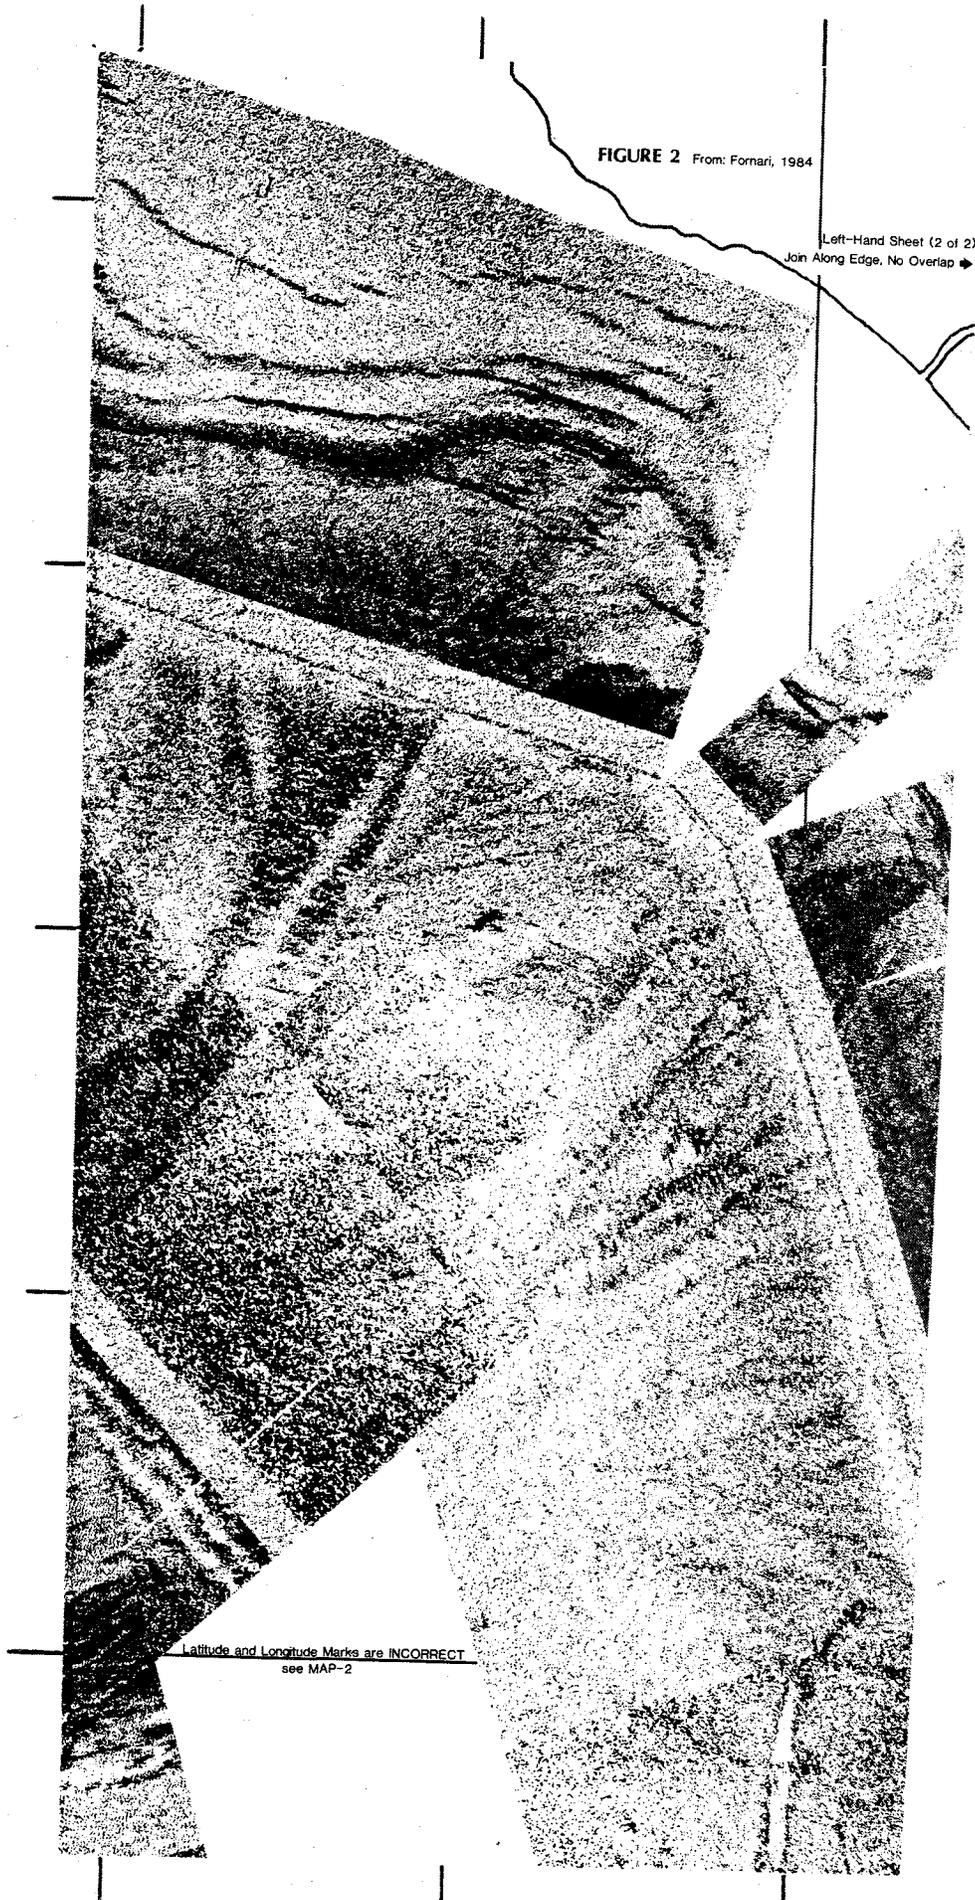
FIGURE 2 From: Fornari, 1984

Figure 2 is an enlarged section of the side-scan mosaic that covers the seafloor west of Kahe Point and is of primary interest with regards to the deployment of an OTEC cold-water pipeline. MAP 2 is the corresponding interpretative map for this record section. The pattern of the fan-shaped reflectivity zones shows a general funneling into the axis of the Kahe Point re-entrant.

The seafloor observed there (TURTLE, Fornari, 1983) is largely sediment-covered with only minor rippled bedforms and no indications of large cobbles or other seabed features that would render the terrain highly-reflective. In the northern part of Figure 2, there is another swath of terrain that appears to follow the axis of the bathymetric re-entrant. The location and character of these more reflective zones could indicate that the axes of the re-entrants act to channel tidal swashing thereby winnowing fine-sediments and leaving behind a gravelly lag deposit that is more reflective.

The trend and character of the carbonate escarpment is easily seen on Figure 2. The width of the escarpment terrain (plan-view map area) is relatively constant. At the southern end of the re-entrant, the width is about 150 m, in the middle it is approximately 200 m, and at the northern end it is only 100 m wide. The base and top of the escarpment are marked by abrupt changes in acoustic reflectivity. The trend of the escarpment top and base on Figure 2 are in excellent agreement with the discrete portions of the escarpment top and base which were mapped with TURTLE (Fornari, 1983).

Although there are problems with multiples on the shelf area, a tentative pick has been made for a terrace step which marks a brief low-stand of sealevel in the Quaternary. There is also a zone of slightly higher reflectivity along the base of the escarpment which, with the aid of TURTLE dive data, has been mapped in as the seafloor area covered by carbonate cobbles and large blocks (shaded area on Figure 2) (Fornari, 1983). During TURTLE diving, the base of the carbonate escarpment was found to merge with the shoreward limit of the boulder zone. The character of the side-scan record in this area supports this interpretation and suggests that it is indeed the case for much of the length of the escarpment in the Kahe re-entrant. Also the tapering of the boulder zone is apparent on the side-scan records and corroborates the findings of dive 423-20 which traversed a much narrower boulder zone than that observed by the dives further to the south (Fornari, 1983).
