Interaction of Antifouling Paints and Steel

The present chapter contains a discussion of the available information on these two aspects of the interaction between antifouling paints and metallic structures. No attempt is made to consider the subject of anticorrosive coatings more generally.¹

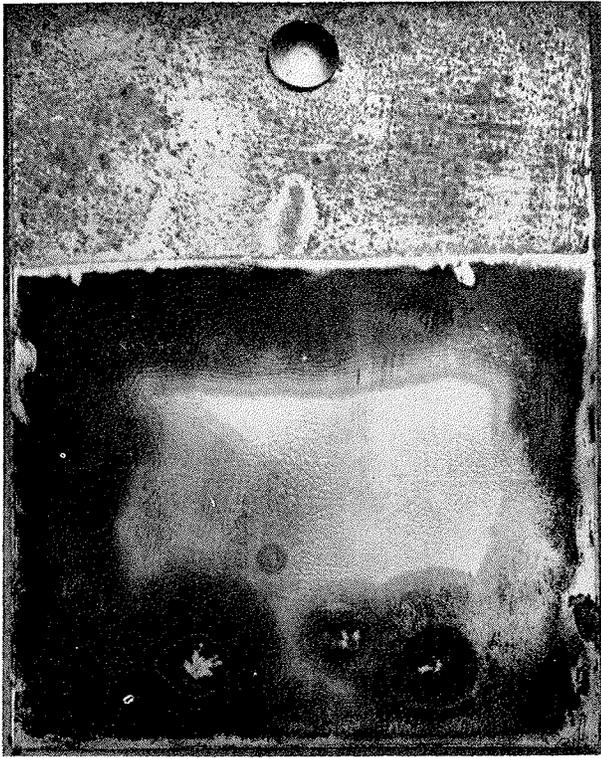
FIGURE 1. Coppery deposit formed under a commercial yacht paint applied directly to zinc. The paint has been removed with organic solvent. Exposure 4 weeks, upper third of panel unpainted.

Figure 1 shows the deposit formed under the paint coating of a zinc panel. The deposit is heaviest near the margin of the unpainted area and near the edges of the panel where presumably the paint film was broken.

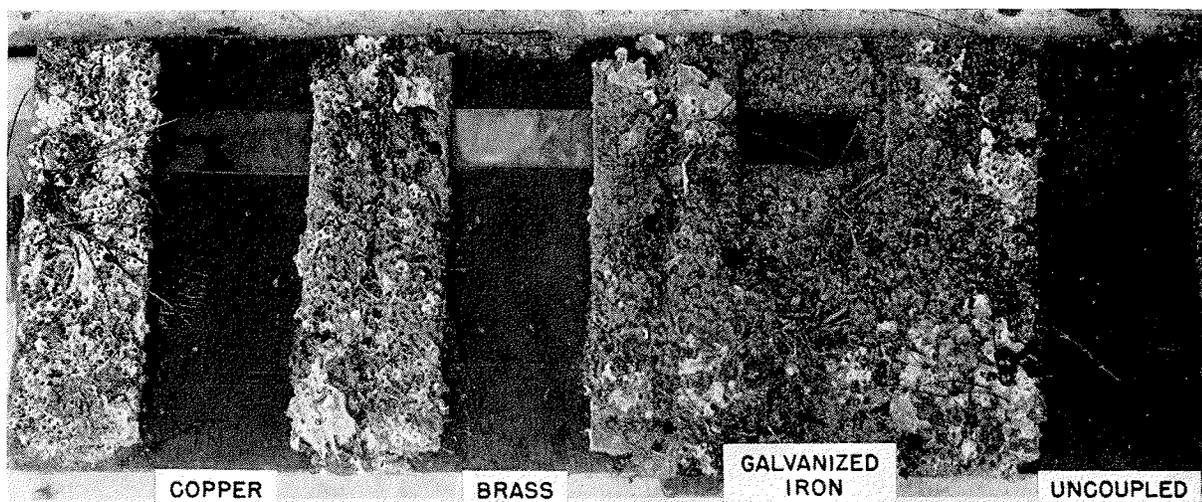
FIGURE 2. Fouling of a commercial brand of yacht paint when coupled with galvanized iron. Surfaces coupled with copper and brass and uncoupled remain unfouled. Exposure 60 days.

In addition, it has been found that similar results are not obtained if strips of copper or brass are applied to the metallic copper paint instead of a more base metal (see Figure 2). Inactivation is not obtained if the iron is not in contact with the metallic copper paint film. If a 2-inch band of cuprous oxide paint, such as 143, separates the iron from the metallic copper paint AF12, the latter is completely protected from inactivation, though without this protection it would foul for a distance of several feet. The corrosion of the metal is also reduced to normal values by this degree of insulation. Thus, the results shown in Table 13

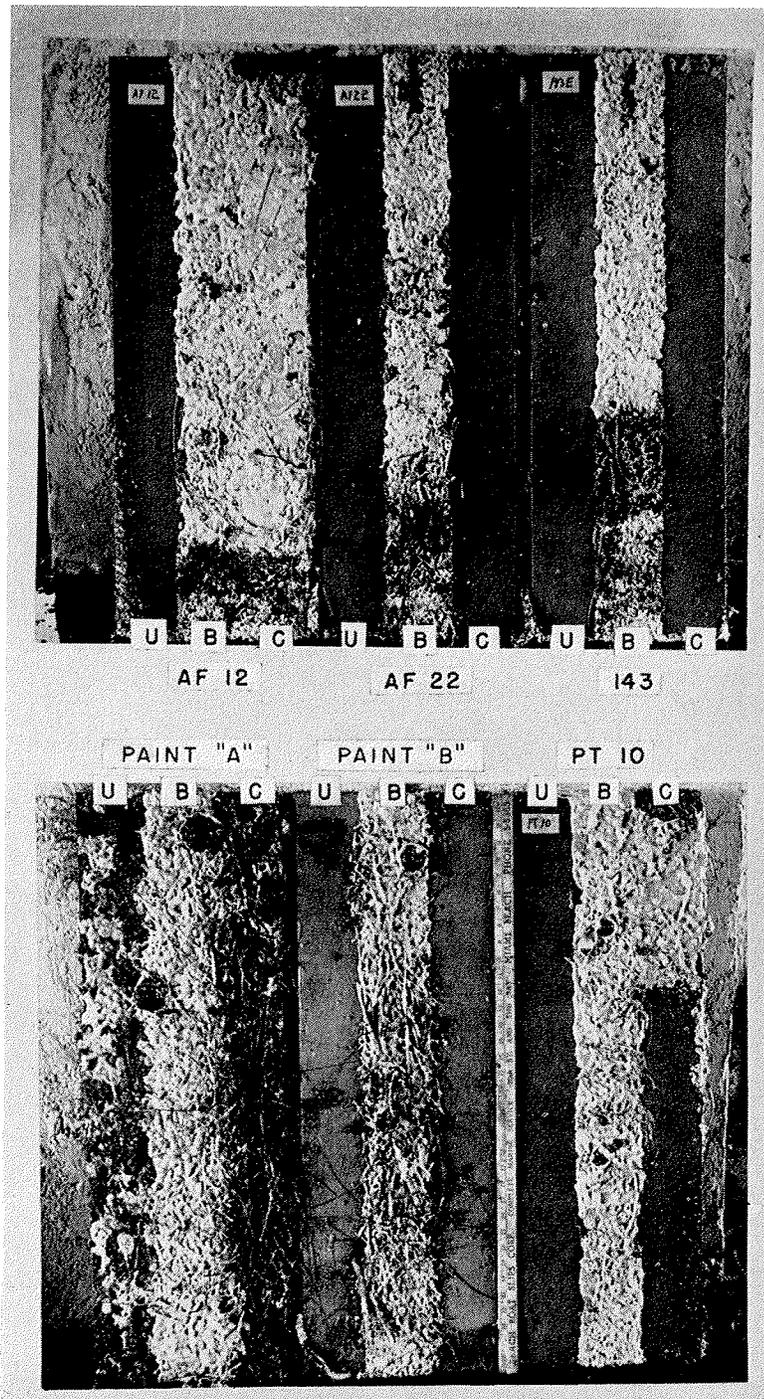
FIGURE 3. Inactivation of antifouling action of metallic copper paints, PT10 and AF12 when coupled to galvanized iron. No inactivation occurs with the cuprous oxide paints AF22 and 143E or with Commercial Paint "B". Commercial

Paint "A" fouled whether coupled or not. Exposure 91 days. U, uncoupled B, bare wood, C, coupled.

³ The experimental set up is shown in Figure 3, which illustrates also the attendant fouling phenomena.

These relations between corrosion and inactivation are demonstrated in Table 10 and illustrated in Figure 3.

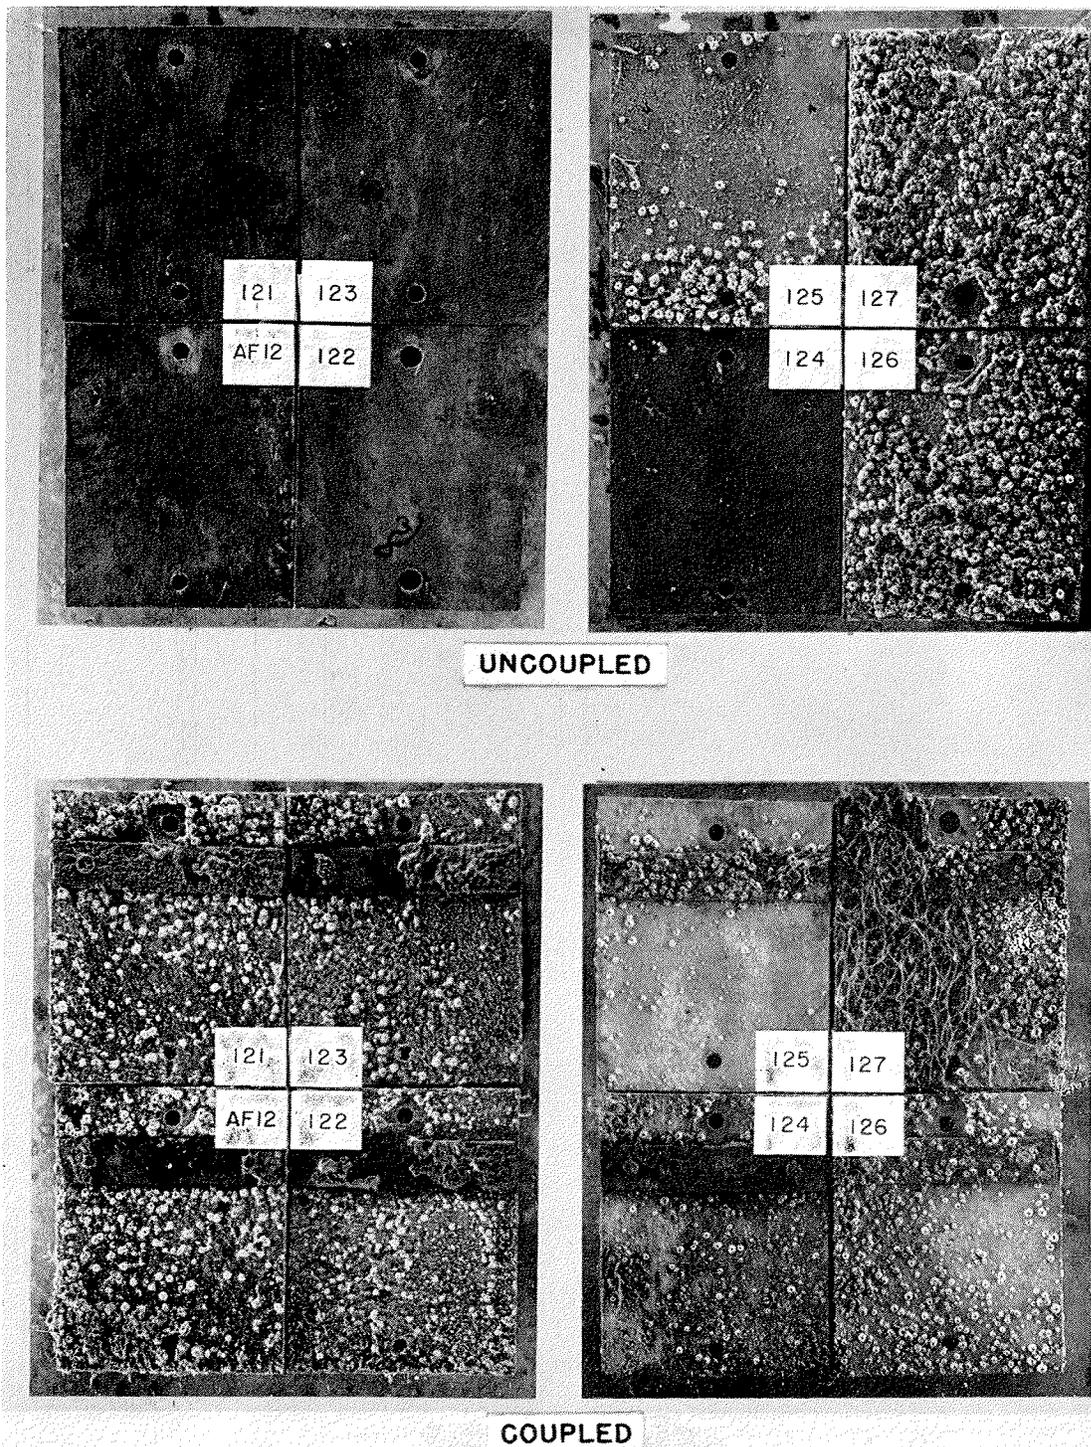
FIGURE 4. Fouling of series of dilutions of metallic copper paint, AF12, applied to wood when uncoupled and when coupled to steel. The more heavily loaded samples, AF12 to AF124, are inactivated by coupling. Exposure 30 days.

very similar relation was demonstrated in the experiment recorded in Table 7 in which AF12 was employed, the results of which are recorded in Figure 4. Inactivation was evident in all samples containing 22.5 per cent of Cu or more.

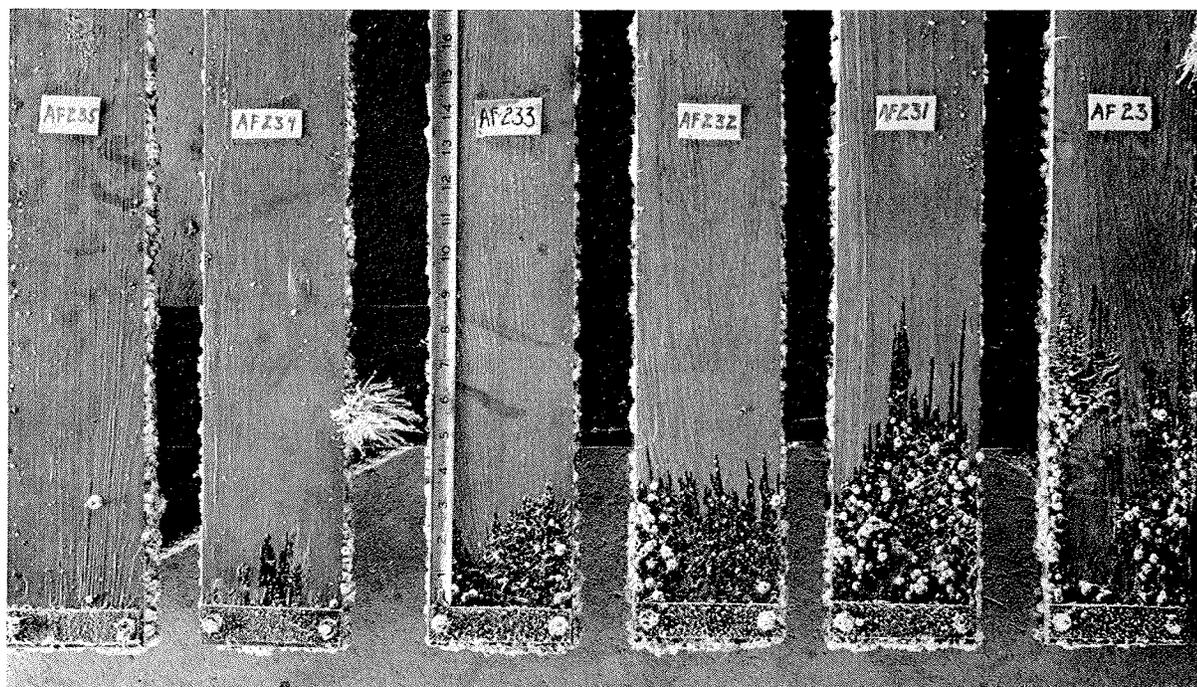
FIGURE 5. Distance of inactivation of a series of dilutions of AF23 containing various amounts of metallic copper. Dilution increases from right to left.

The distance over which inactivation extends from the metal strip also appears to depend very largely on the loading of the paint with metallic copper. Figure 5 illustrates the extent of inactivation in a series of dilutions of AF23. In Table 12,

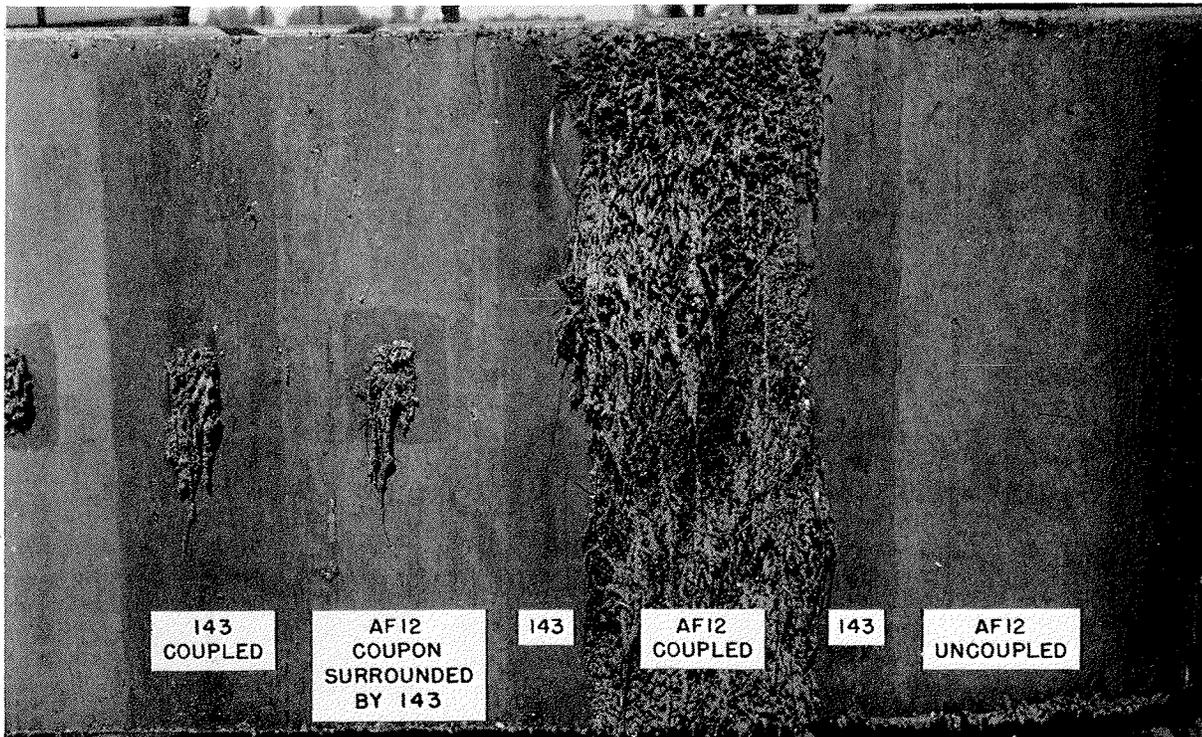
FIGURE 7. Protection of metallic copper paint, AF12 from inactivation by a galvanized iron coupon by surrounding the coupon with an area painted with the cuprous oxide coating 143E. Exposure 60 days.

were obtained in an experiment of 115 days' duration, and are illustrated in part in Figure 7. This and other experiments show that wood does not contribute effectively to completing the supposed galvanic circuit.

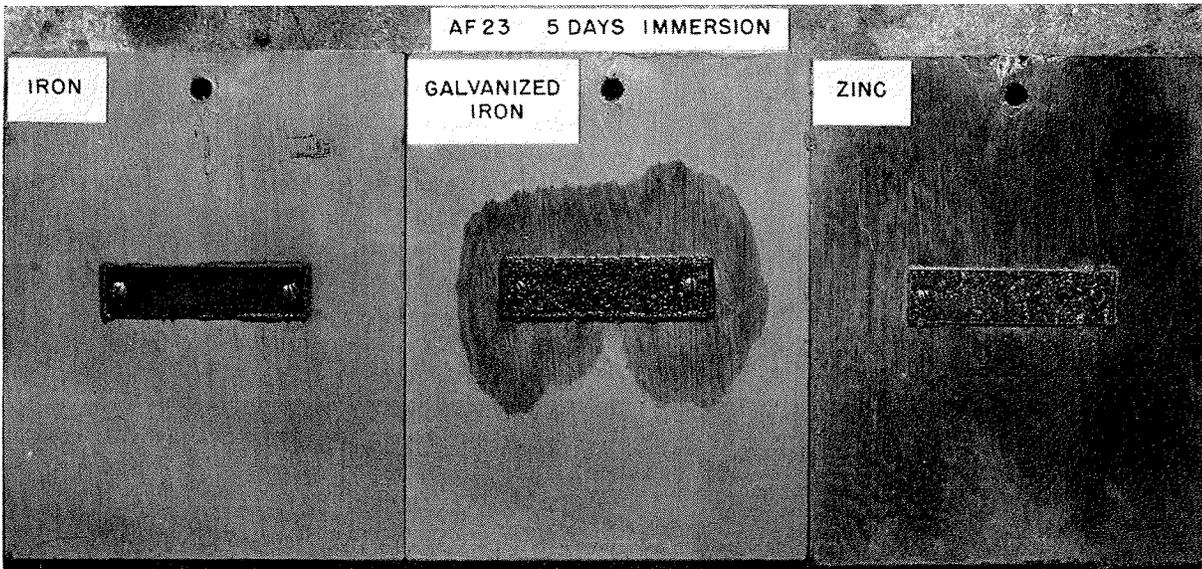
FIGURE 8. Discoloration of metallic copper paint AF23 surrounding coupons of iron, galvanized iron and zinc. Exposure 5 days.

When strips of iron or zinc are attached to metallic paints, the surface of the paint becomes darkened in the immediate neighborhood of the metallic strip on exposure to sea water. The darkened area gradually extends to some distance depending on the galvanic activity of the paint and the composition of the metallic strip. Figure 8 illustrates this effect. Darkening has just commenced about the iron coupon, but has spread for

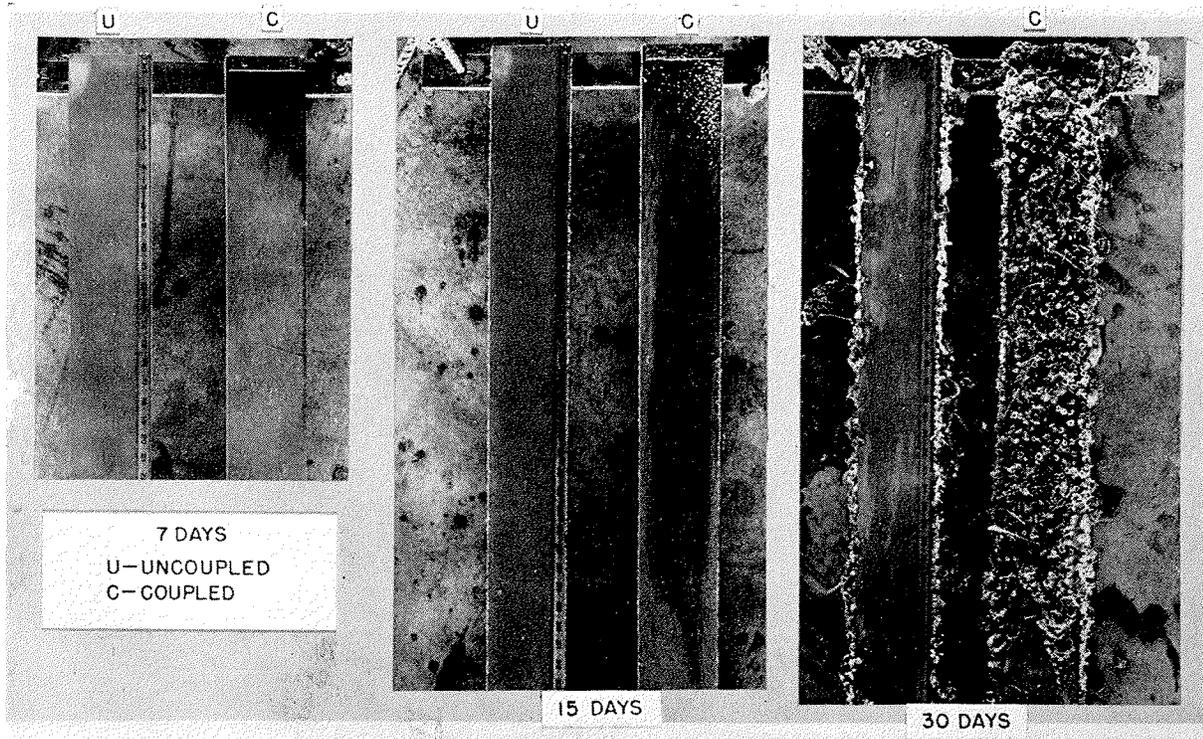
FIGURE 9. Discoloration of metallic copper paint AF23 preceding inactivation of antifouling action by coupling to galvanized iron.

several inches from the galvanised iron coupon, and has covered the entire panel to which zinc was attached. This darkening has proved to be an invariable precursor to the subsequent fouling of the paint. The correspondence between the darkening and the subsequent extent of fouling is illustrated in Figure 9. Metallic copper paint when applied to wood is also frequently observed to blister severely near an attached strip of iron or zinc.

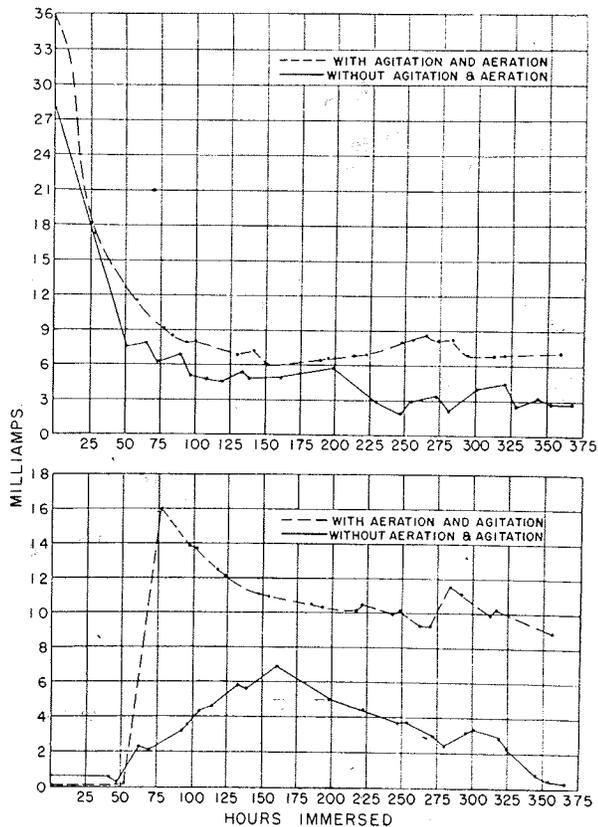
FIGURE 10. Galvanic current from copper-steel couple (above) and from metallic copper paint-steel couple (below). From Alexander and Benemelis (1).

current developed which increased markedly after an initial period when little or no current flowed. Figure 10 shows the current produced by such a couple during immersion, and also that produced by a similar couple of copper and steel. At the time of its maximum development the current produced by the paint-steel couple is as great or greater than that of the copper-steel couple. The resistance of the paint films was also shown to decrease during coupling to values characteristic of good conductors. This change in resistance did not occur if the paint films were soaked without being coupled to steel, and is evidently the result of some change produced in the paint as the result of coupling. These phenomena did not occur in films having a pigment-volume ratio of 25 per cent or less, which is close to the limit mentioned on a previous page below which inactivation of antifouling action does not occur.

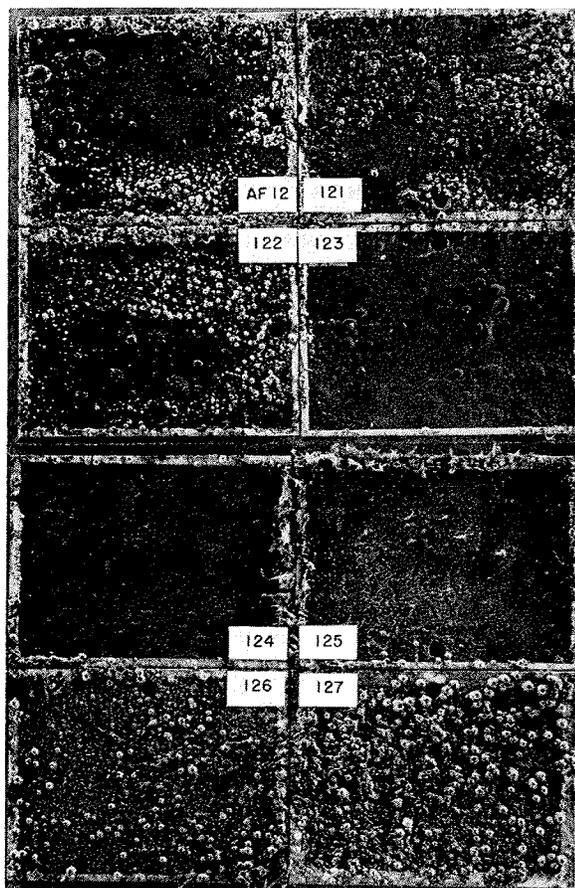
FIGURE 11. Fouling of a series of dilutions of metallic copper paint, AF12, applied to steel over a single coat of P8 primer. Exposure 30 days. Note that the more heavily loaded samples, AF12 to AF122, are inactivated. Compare Figure 4 for controls on wood panels.

lustrated in Figure 11, which shows the fouling of a series of dilutions of AF12, applied to steel over a single coat of P8 primer, after one month's exposure at Miami. The copper contents of these paints are recorded in Table 7, and their fouling when applied to wood, coupled or uncoupled, is illustrated in Figure 4. The more heavily loaded coatings AF12, 121, 122, have fouled heavily, just as they did when applied to wood and coupled to steel. The less heavily loaded coatings AF123 and 124 have retained some fouling resistance. The most dilute coatings, AF125, 126, 127, fouled from inadequate toxicity, as they did when applied to wood without coupling. The result of this experiment parallels that of the coupled wood application so closely as to leave little doubt that the failure of the heavily loaded coatings is attributable to galvanic action.

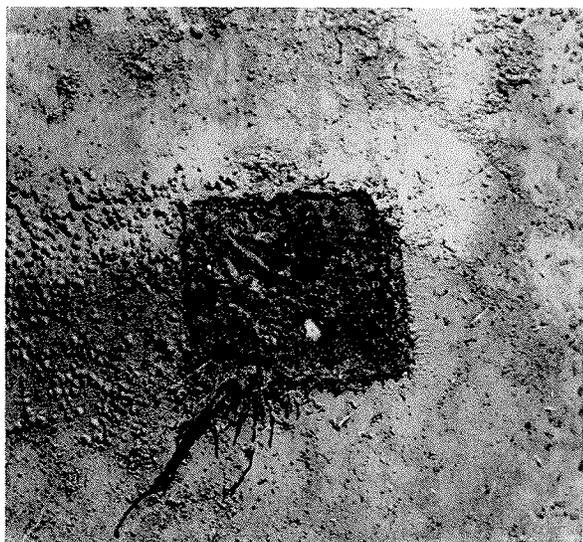
FIGURE 12. Fouling on rust deposit which formed downstream from a holiday in antifouling paint. Exposure 5 months. Reproduced by courtesy of F. L. LaQue, International Nickel Company.

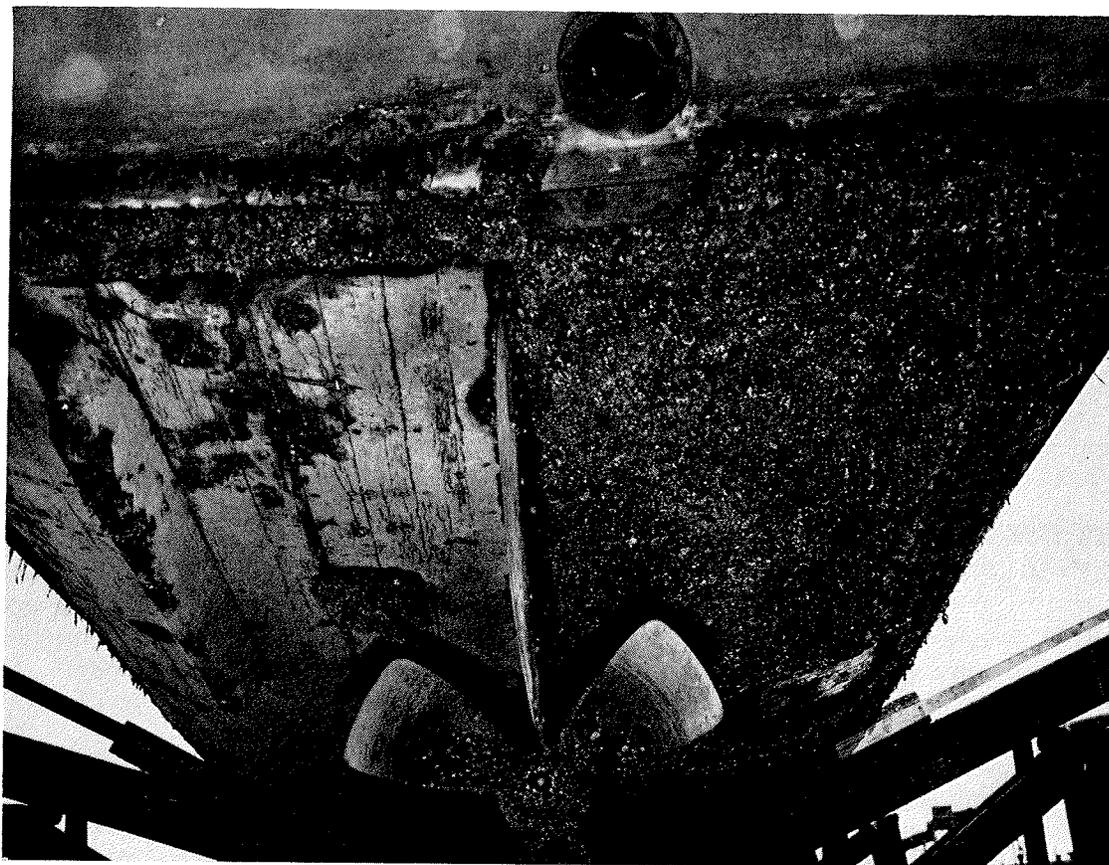
FIGURE 13. Fouling of metallic copper paint AF23 induced by a galvanize.iron patch which may be seen to right of propeller. The cuprous oxide paint AF22 coating the port quarter has not been inactivated. The uncoupled AF23 on the port bow quarter was also unfouled.

On wood construction, the danger of corrosion and inactivation are much less serious. Young and Seagren (18) suggest that accidental contact of chain, rudder posts, and similar ironware with the antifouling paint on a wood hull would have very little deteriorating effect on antifouling efficiency, unless the contact area be large. However, experiments show that heavily loaded metallic copper paints of the type recently developed may result in severe corrosion of galvanized iron fittings and fastenings which they contact. Fouling of the paint in the neighborhood of metallic contacts may also result. This is illustrated by Figure 13, which
